Strategic Equipment Changes at Key Milestones Assisted a Plus-Size Patient to Recover Baseline Mobility and Go Home

Kirsty McLelland, National Bariatric Lead, Medstrom

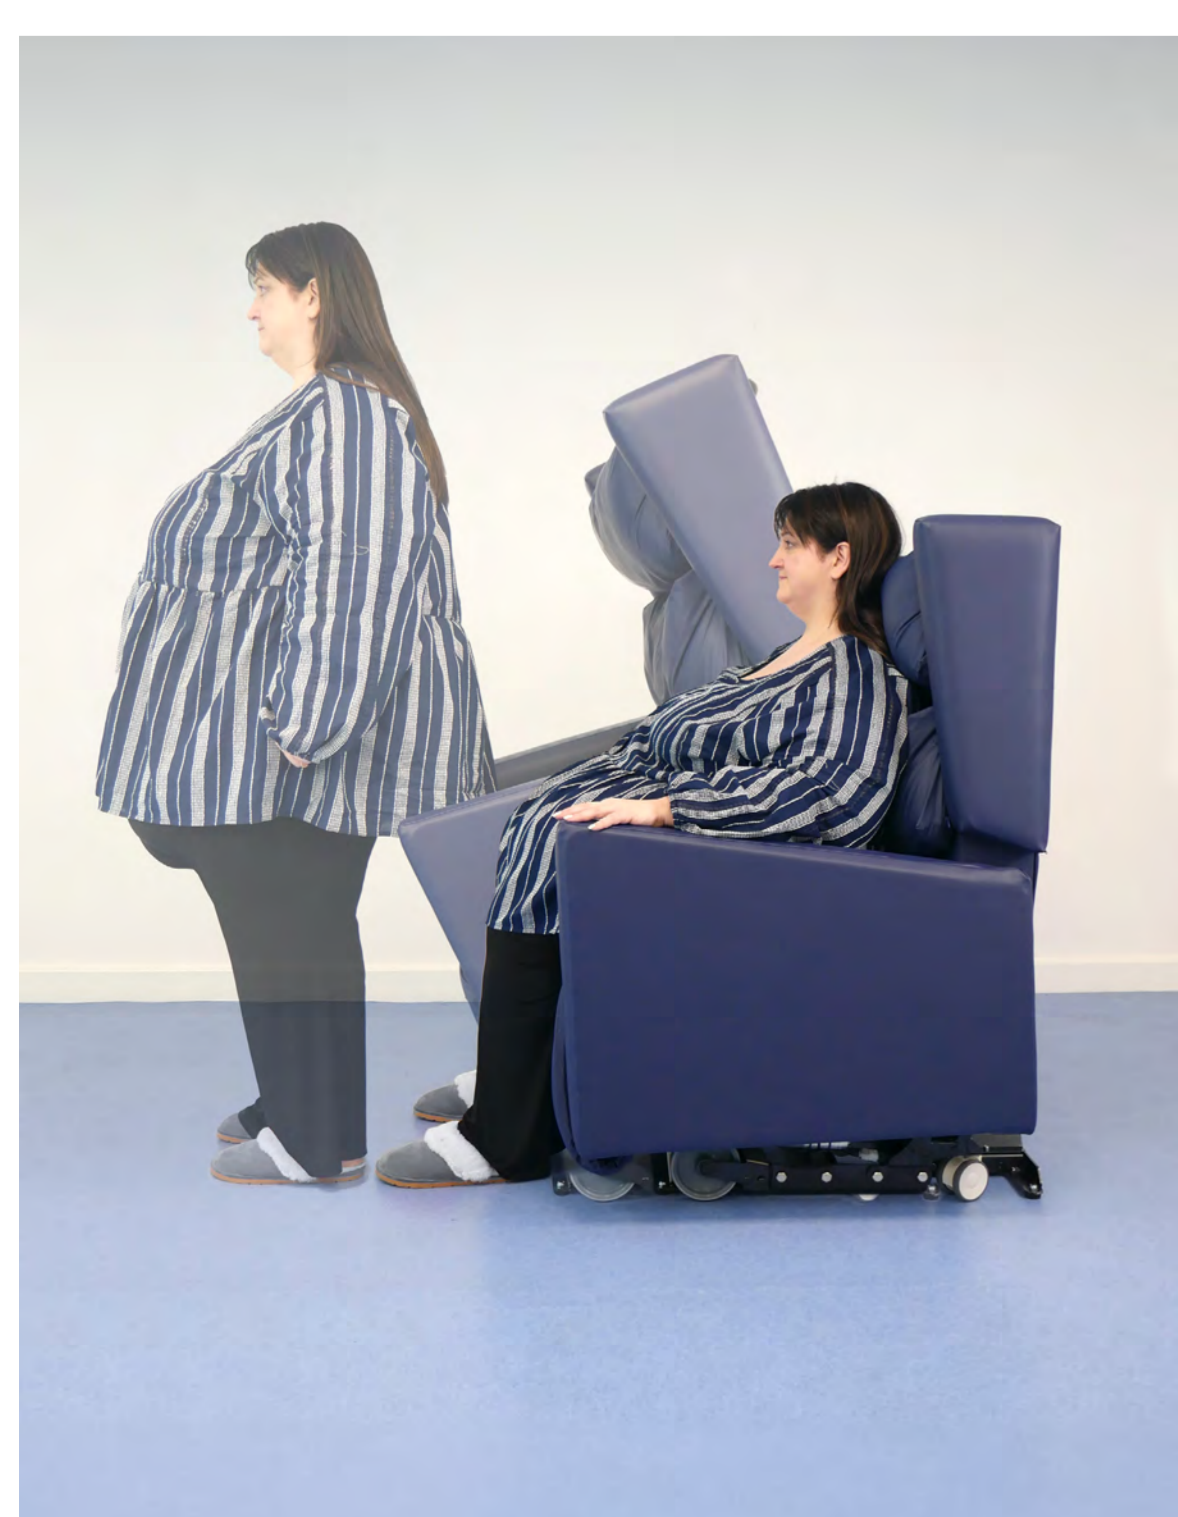
Figure 1. Equipment solutions for different stages of Patient H's recovery journey.

Initially bedbound, Patient H needed a suitable bariatric bed and support surface for comfort, in-bed mobility, and pain management. The **Versatech 1100 bed**, with an expanding platform and low height of 21cm provided a suitable surface for repositioning and mobilisation, and a **TurnCair 1000 mattress** assisted with repositioning (Figure 1).

Once Patient H was well enough to get out of bed, a **Gantry Hoist** and **Riser Recliner** chair were provided (Figure 1). Using the hoist preserved her energy for standing practice, and allowed her to sit out of bed.

enough to start standing. To help achieve this, the **Octopannus support belt** was introduced, giving a dramatic improvement in her ability to stand (Figure 1).

When Patient H was ready to start walking, a **Bariatric Walking Vest**, **Rotunda**, and **Shower Chair/Commode** were brought in (Figure 1).
